P3-1 Guide Arm

Refurbishment for original quality and performance

P3-1 Guide Arm – Refurbishment

Uniform and consistent pressure for original quality and performance

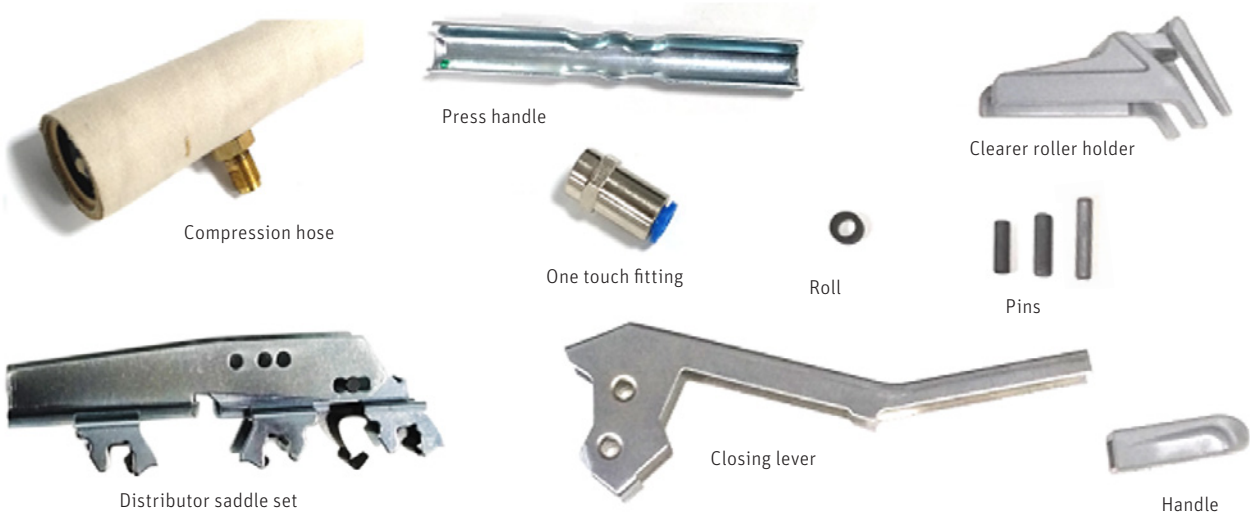
Overview of refurbishment package

Replacing worn out and aged parts help restore the original performance of the drafting system. It ensures effective load and consistent drafting and output yarn quality. Improvement in terms of load uniformity and performance can be seen before and after the repair service conducted by Rieter service engineers.

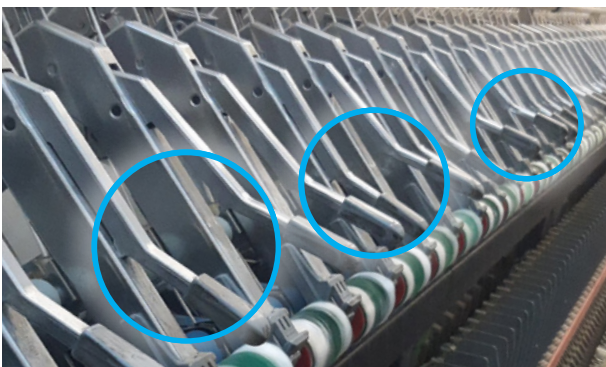
Before refurbishment – variation in load

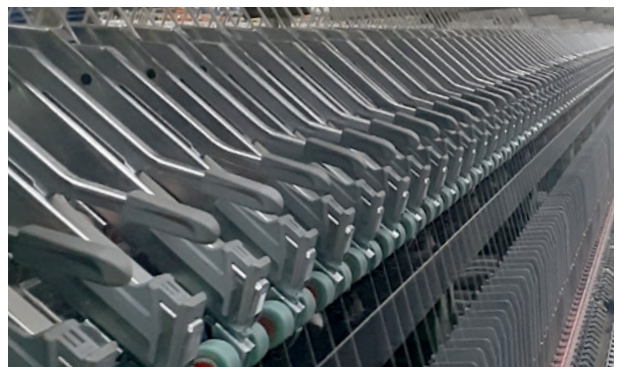
After refurbishment – uniform load
