Suction drum refurbishment
Compact spinning K 40, K 42, K 43, K 44, K 441, K 45, K 46, K 47 and K 48

Suction Drum Refurbishment

For original compacting performance and yarn quality

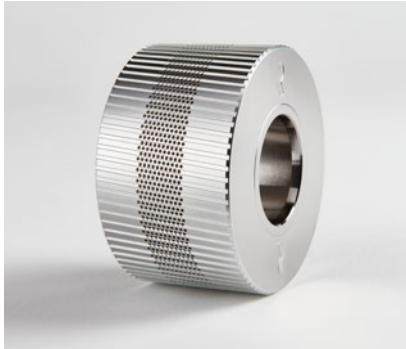
Perforated Suction Drum

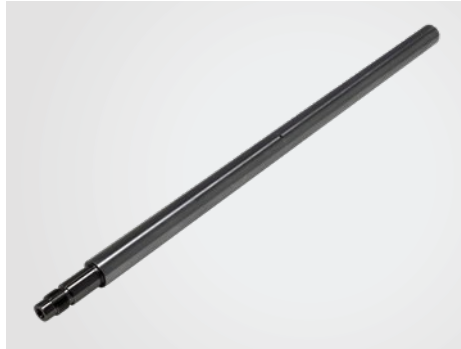
Bottom roll shaft

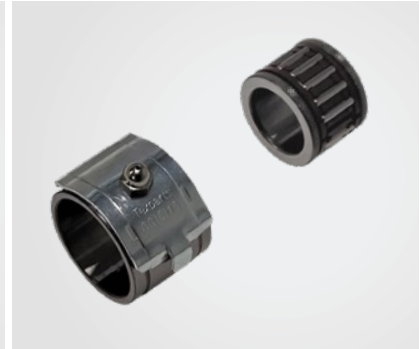
Needle bearing set

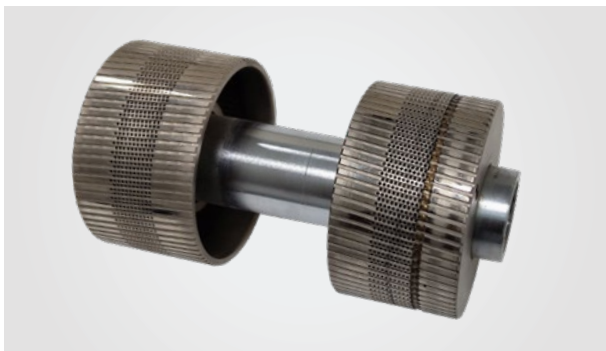
Worn-out drum before refurbishment

Equipped with the know-how of the OEM, Rieter repair services performs the refurbishment of the drums that show significant wear and tear in the most cost-effective manner with the fastest turnaround time. Worn-out parts are identified through a thorough inspection comprising drum eccentricity test, shaft eccentricity test, visual inspection through a digital camera inspection and a very detailed physical verification process. Reusable parts are cleaned through high-frequency ultrasonic waves and inspected through a digital microscope to ensure the best possible performance of the drums.

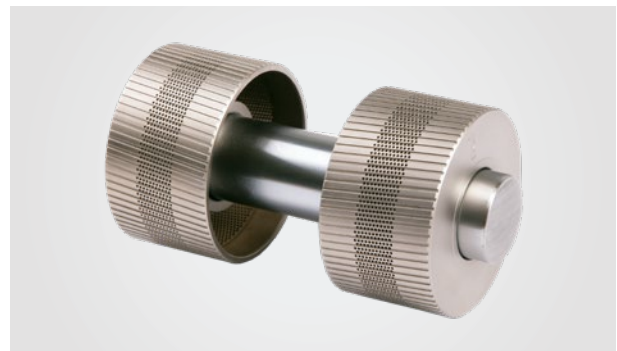
Improved wear-resistant drums after refurbishment

An in-house developed state-of-the-art drum refurbishment machine is then used to precisely inspect, dismantle and reassemble the high-quality OEM parts. Improved design wear-resistant coated suction drums are available as an option for replacing the worn drums in existing machines. This refurbishment helps restore compact yarn quality in terms of yarn hairiness, imperfections, unevenness and yarn breakages. The quality consistency between spindles is ensured and the periodic faults due to suction drums are eliminated, resulting in a better and more uniform fabric appearance.
