Friction Drum Motor Refurbishment

For original performance and lifetime

Increase Machine Up-time with Friction Drum Motor Refurbishment

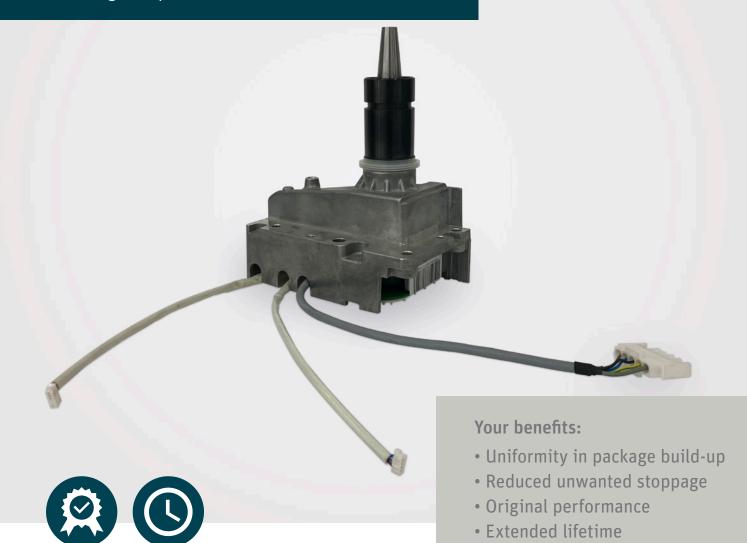
The friction drum plays a critical role in package build-up. The friction drum motor located in each winding position drives the yarn guide drum through an integral drum shaft mechanism.

The internal parts in the friction drum motors tend to wear out over time due to continuous operation. If this out of tolerance components of the mechanical drive elements is not identified on-time, it may result in the failure of the associated components like electronics boards. This leads to the complete breakdown of the drum motor resulting in huge production loss.

Dismantled integral components of the motor are cleaned thoroughly to remove oily or greasy dirt particles. Replacing the bearings, worn-out drum shaft, protection cover and calibration of the electronics PCB helps restore the original performance of the friction drum motor. The solution provided by Rieter ensures trouble-free operation and leads to uninterrupted production and uniform package build-up in all winding positions.

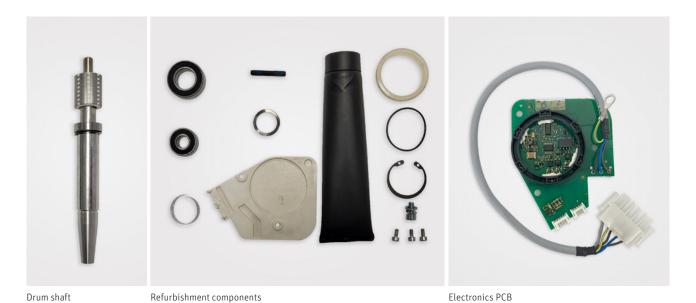
Overview of refurbishment

Rieter offers the refurbishment of the friction drum motor by replacing the defective components with original components based on the analysis of the units received from the customer.
